SAFETY RECALL TO INSPECT AND REPAIR YOUR VEHICLE'S TRANSFER CASE

Safety Recall No. B17 – Transfer Case

1991-1996 (B7) Dodge Stealth R/T Twin Turbo All Wheel Drive (AWD)

Oil leakage from the transfer case on about 9,100 of the above vehicles may cause the transfer case to fail. This could cause the wheels to lock up and result in an accident without warning.

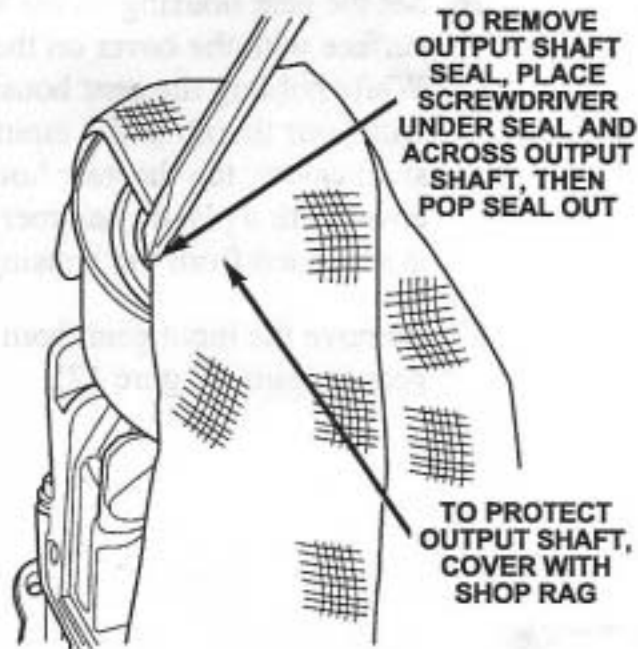
Figure 14

32. Set the adapter housing/extension housing assembly on the work surface with the output shaft facing upward.
33. Carefully remove the output shaft seal. To remove the seal, place a flat bladed screwdriver under the seal with the screwdriver shaft resting on the extension housing cuff. Remove the seal by quickly hitting the screwdriver handle and popping the seal from its seat (Figure 14).

NOTE: Protect the end of the output shaft by placing a shop rag over it prior to the seal removal.

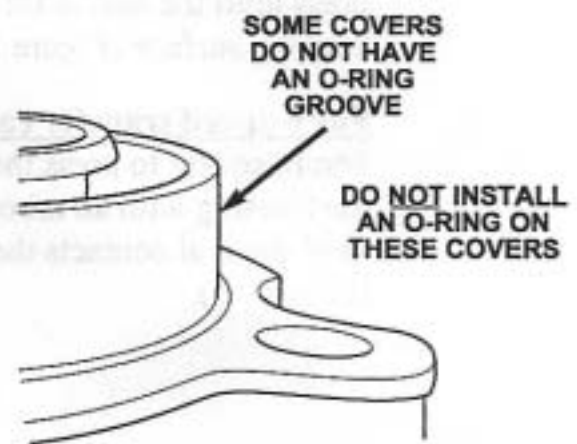
Figure 17

IMPORTANT: Some early-built 5-speed transfer cases did NOT have a cover O-ring (Figure 17). However, some of these covers do have an O-ring groove. A new cover O-ring **MUST** be installed if the cover has an O-ring groove. If the cover does NOT have an O-ring groove, DO NOT install a cover O-ring.
